Hardware Meeting 08.08.2024

Investigation of PAD detectors.

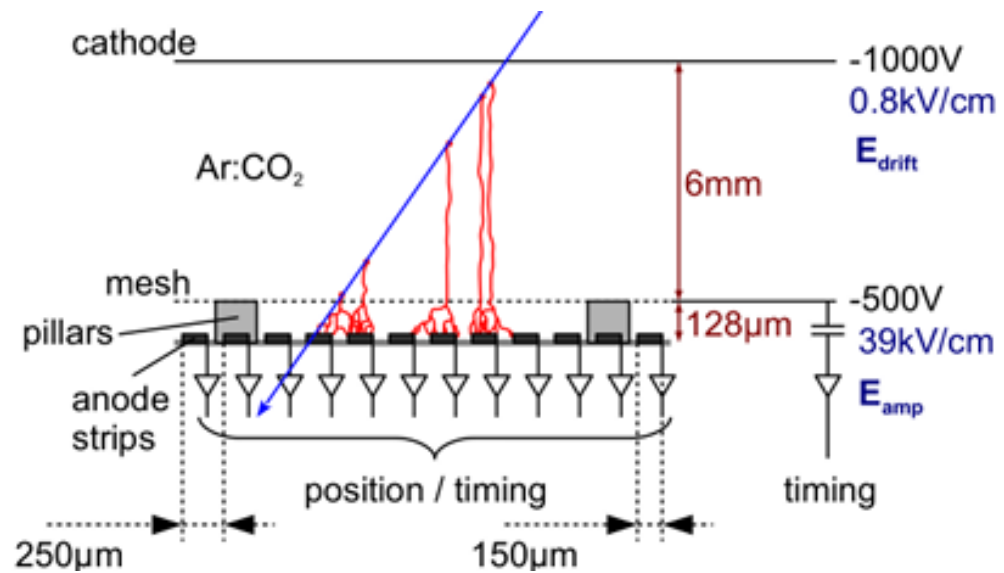
Micromegas detector

MicroMegas Detector (Currently Using TMM's)

- Uses strips in both X and Y
- Require 2APV's for one direction. Total 4.
- More read out channels.

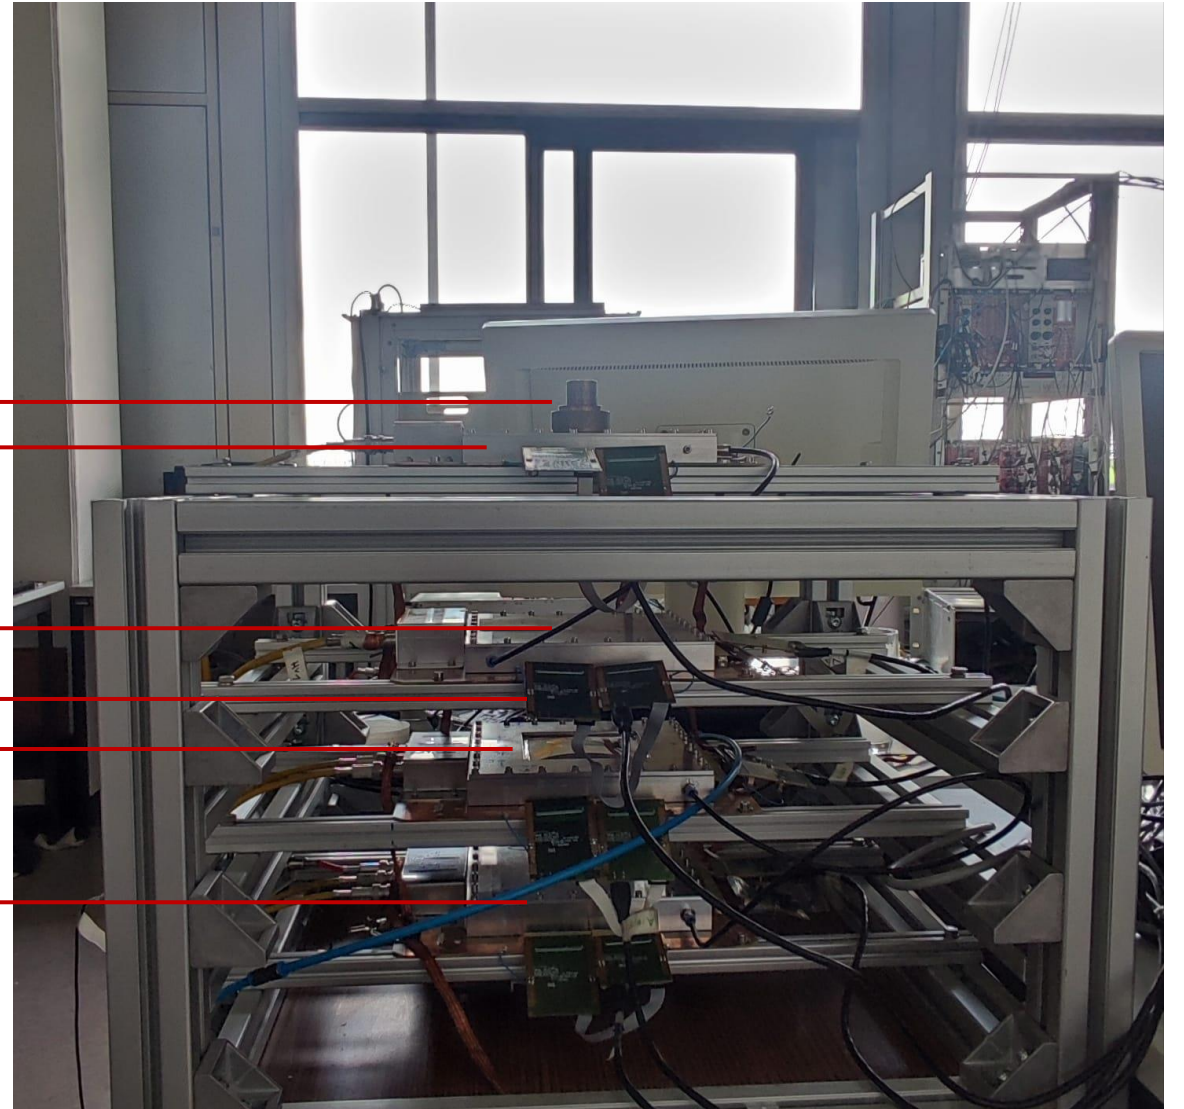
Experimental Setup

- Source: Fe 55.

Source

Detector 1

Detector 2

APV's for readout

Detector 3

Detector 4

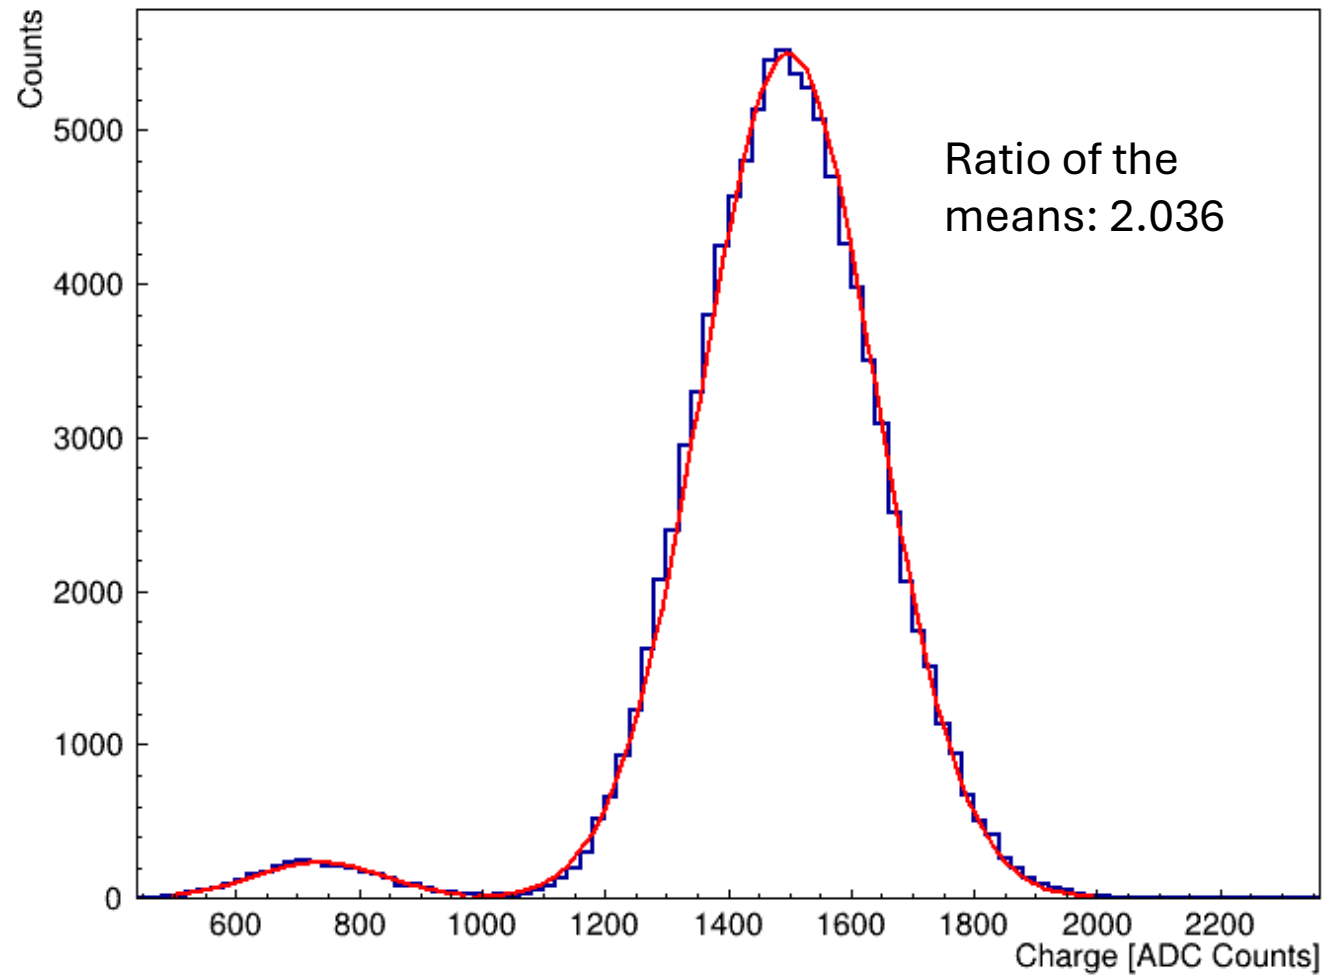
h_ClusterCharge_TMM1Y

Optimizing to find the best energy resolution possible.
